Manhole Inspection Summary

Manhole # S33YY_001MH

Insp Date: **4/16/07 11:20 AM**

Location Address: **5 LOVEGROVE ST**

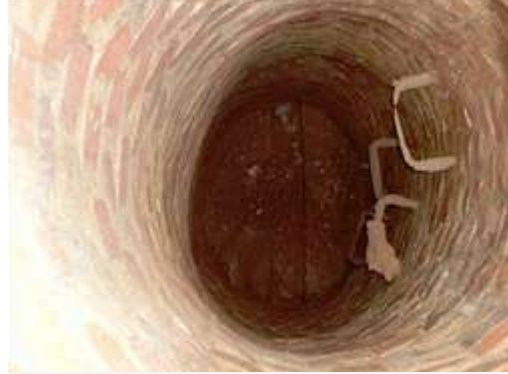
Top View

☒ **Debris** (not Condition related)

Steps

Count: **6**

Missing: **2**

☒ **Corroded**

Corroded and missing steps. Bench and Channel debris

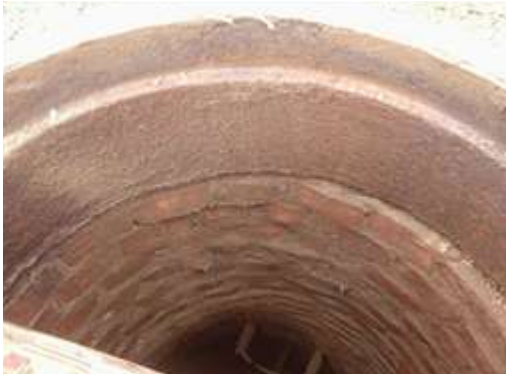
Defect

☒ **Leaks**

Infiltration: ☐ None ☒ **Joint** ☐ Cracks ☐ Mortar ☐ Roots ☒ **Wall**

Frame leaks. Adjustment infiltration - other side.

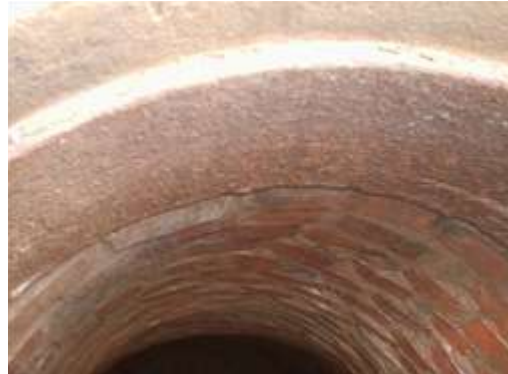
Defect

Frame leaks. Adjustment infiltration.

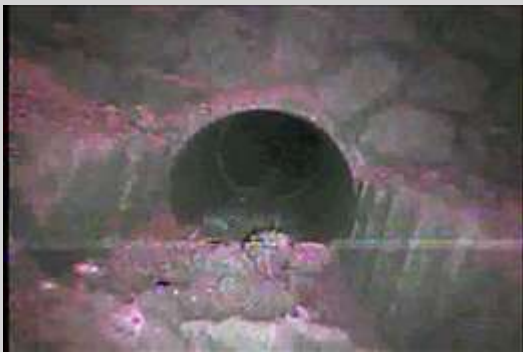
8 in. Circular Gravity Sewer Pipe Out @ 12 O'Clock

Deposits: ☐ None ☒ **Mud** ☐ Sludge ☒ **Debris** ☐ Grease

Silt Depth: **1** (in.) Deposits Extent: **Light**

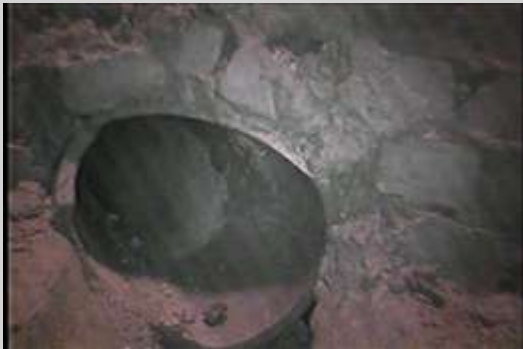
8 in. Circular Gravity Sewer
Pipe In @ 7 O'Clock

Infiltration: **None** Pipe Seal Cond: **Broken**
